POTENTIAL HAZARDOUS WASTE SITE
SITE INSPECTION REPORT

Site number: MSD000693176

Site name: Enterprise Recovery Systems

A site inspection was conducted by Environmental Protection Systems, Inc., personnel at Enterprise Recovery systems (ERS) on September 12, 1984. The facility is located on Cayce Road approximately 1.5 miles North of Cayce, Mississippi. Mr. Joe Spilka, owner, met the sampling team and escorted them during a visual inspection of the property.

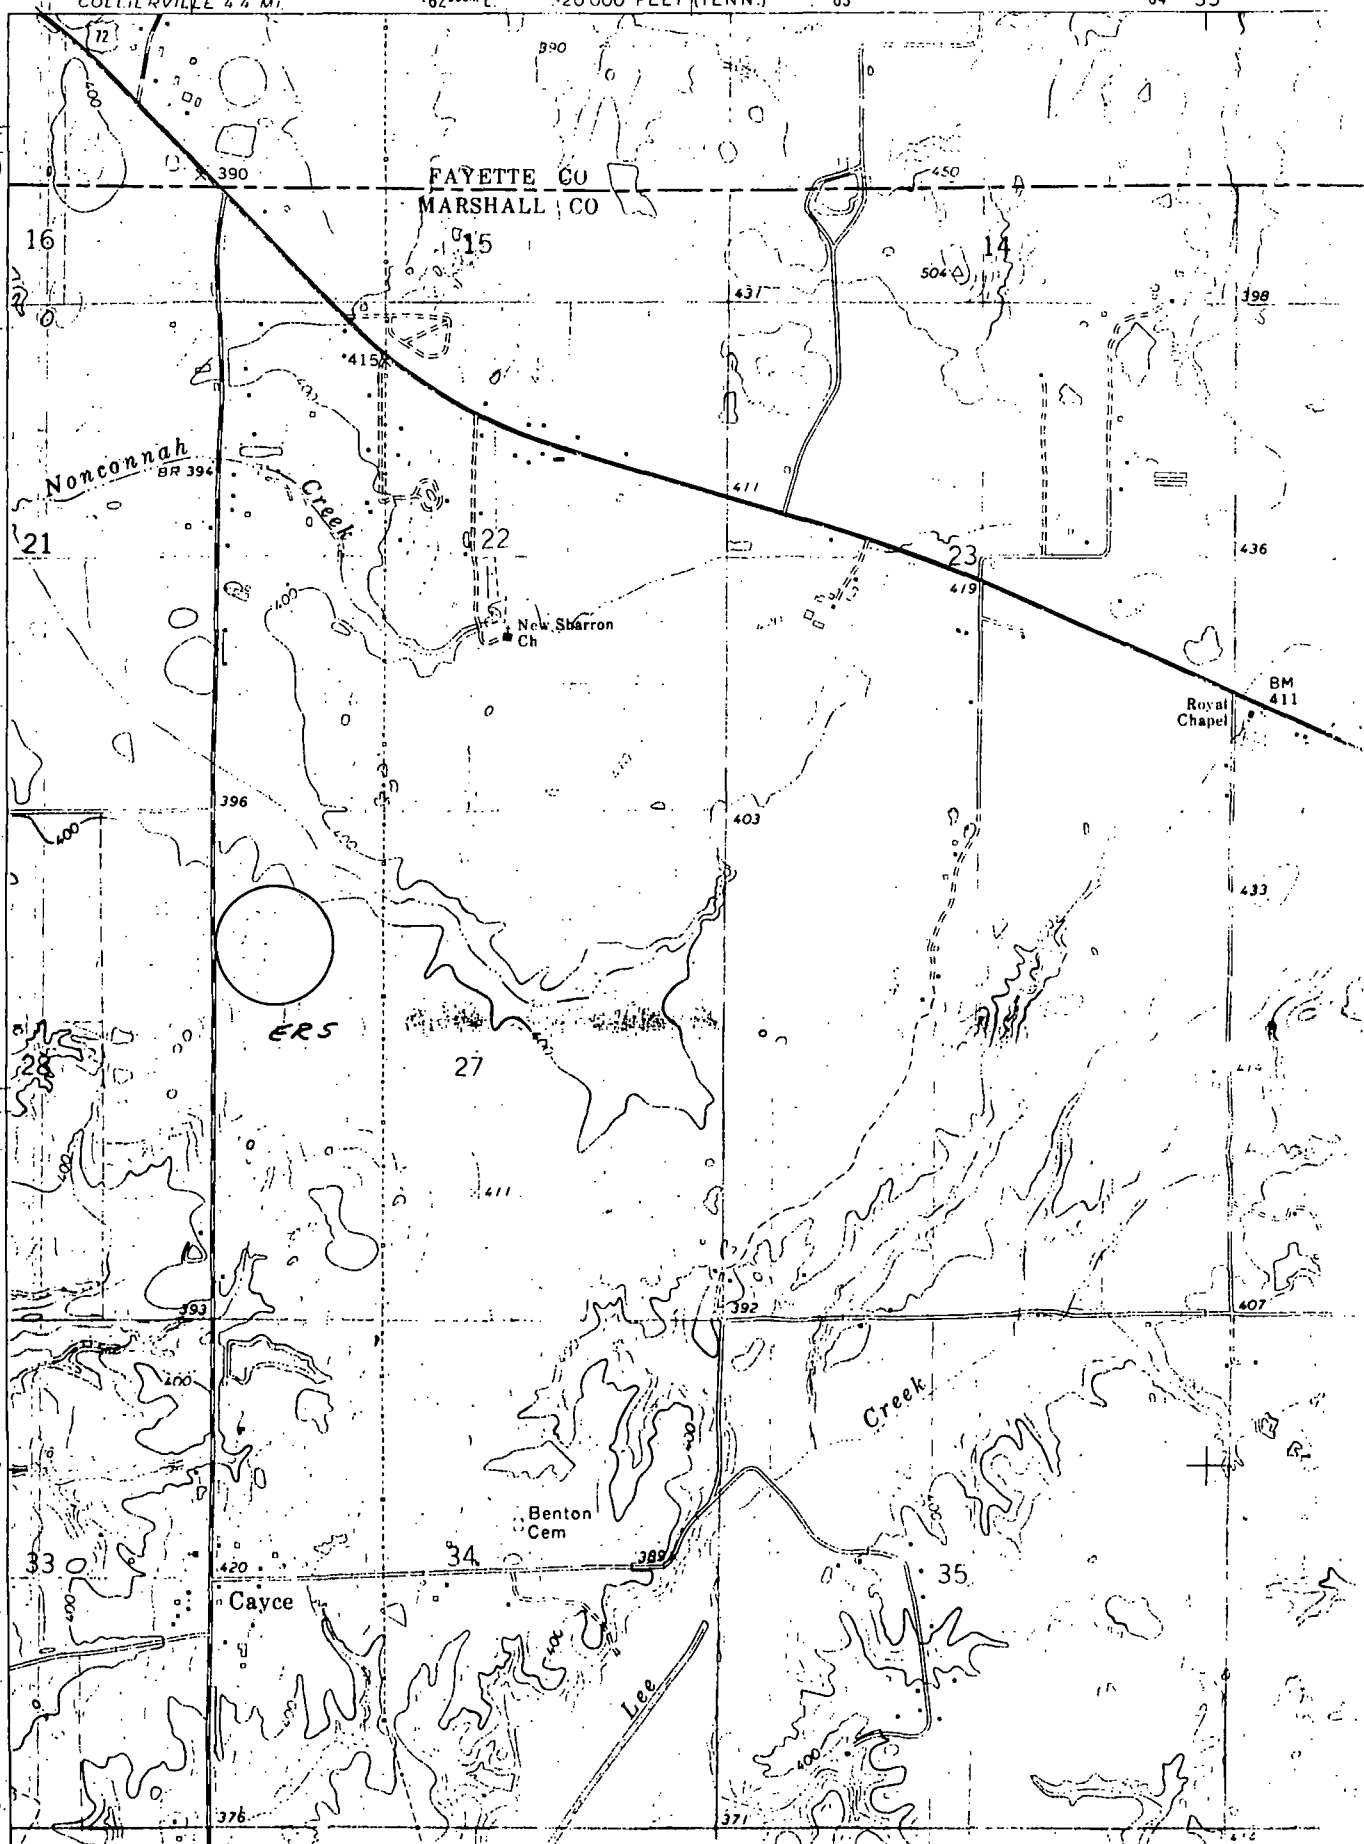
305° 11' SW
(COLLIERVILLE)

UNITED STATES
DEPARTMENT OF THE INTERIOR
GEOLOGICAL SURVEY

89° 37' 30" MEMPHIS (INTERSTATE 240) 17 MI.
35° 00' COLLIERVILLE 4.4 MI. 262000m E 240 000 FEET (TENN.) 63 64 35'
